Survey # WA-II-1014                      Approximate date Ca. 1850  
Street Address 34 North Main Street  
Town, State Keedysville, Maryland  
private X, public

WA-II-1014

34 N. Main St., Keedysville, MD

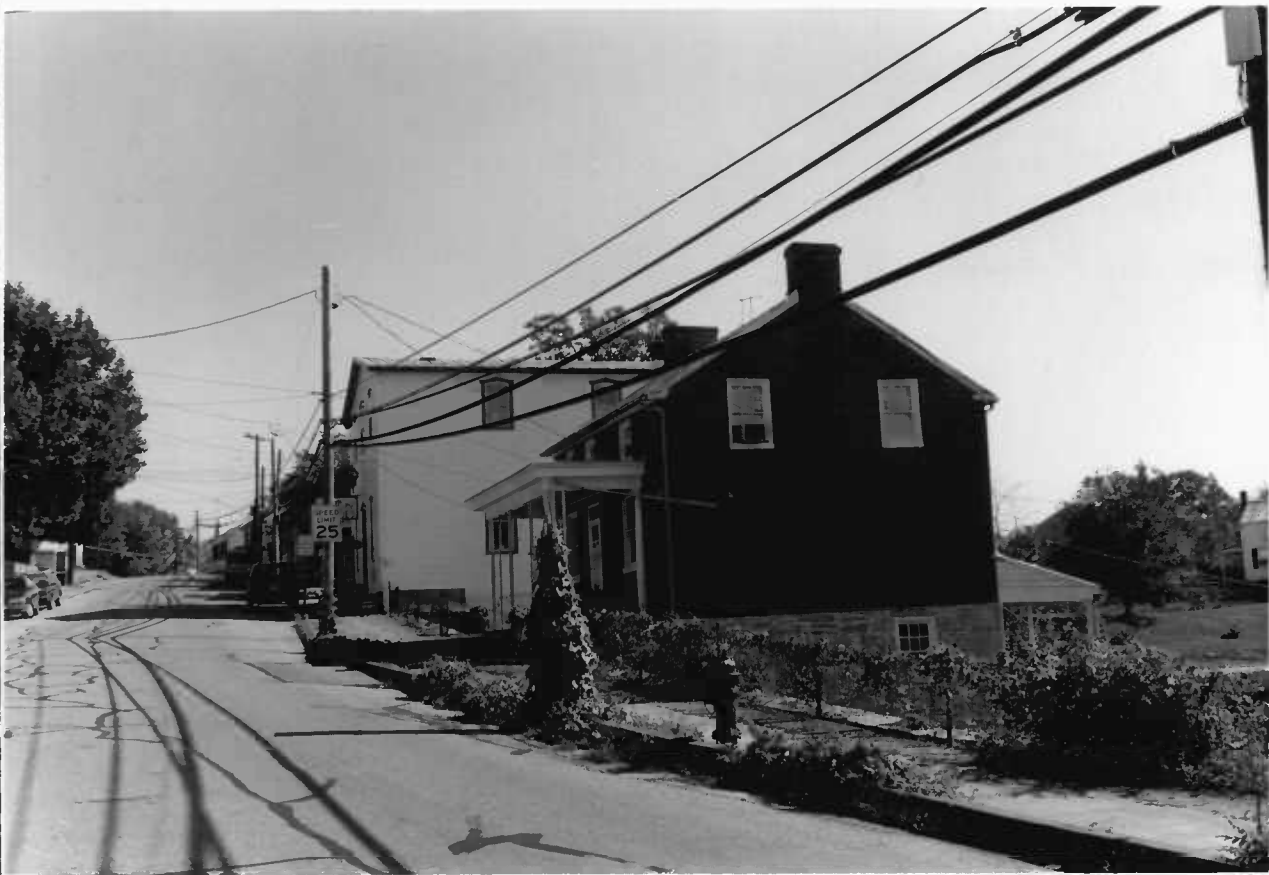
#20

This brick house dates from approximately 1850. Shown on the 1877 Atlas, it is a 1½ story, three bay brick house on limestone foundations that become almost a full story in height at the rear of the building. Windows have six over six pane sash in narrow frames. The main entrance is in the center bay and includes a transom. Chimneys are located inside the end walls. A porch across the front probably dates from about 1900, but is supported by modern metal columns.

NE View, S + W Elevations
